DEPARTMENT OF TRANSPORTATION

Orthotropic Box Girder (OBG)

WELDING INSPECTION REPORT

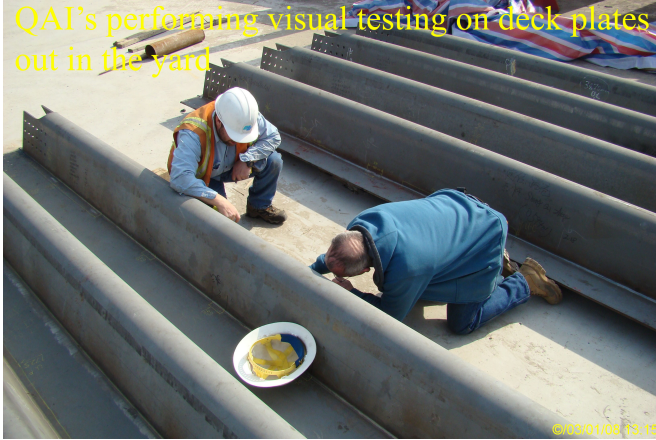
This QAI performed visual testing (VT) on deck panel DP017-001 PJP welds for conformance to the Special Provisions and Code. Weld joint examined were 001 & 006. This QAI was accompanied by two other QAI's who examined weld joints 002, 003, 004 & 005. Data was recorded on the Caltrans QA Visual Inspection Report for the OBG

QAI's performing visual testing on deck plates out in the yard
